# Dealer Pre-purchase inspection

Date completed: 31/05/2023

**Nissan Navara PRO-4X Warrior D23**

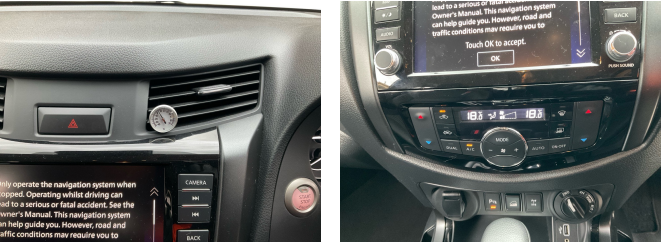
Air conditioning cold and working well at the time of inspection. Normal wear evident to the air conditioning components consistent with the age and mileage.

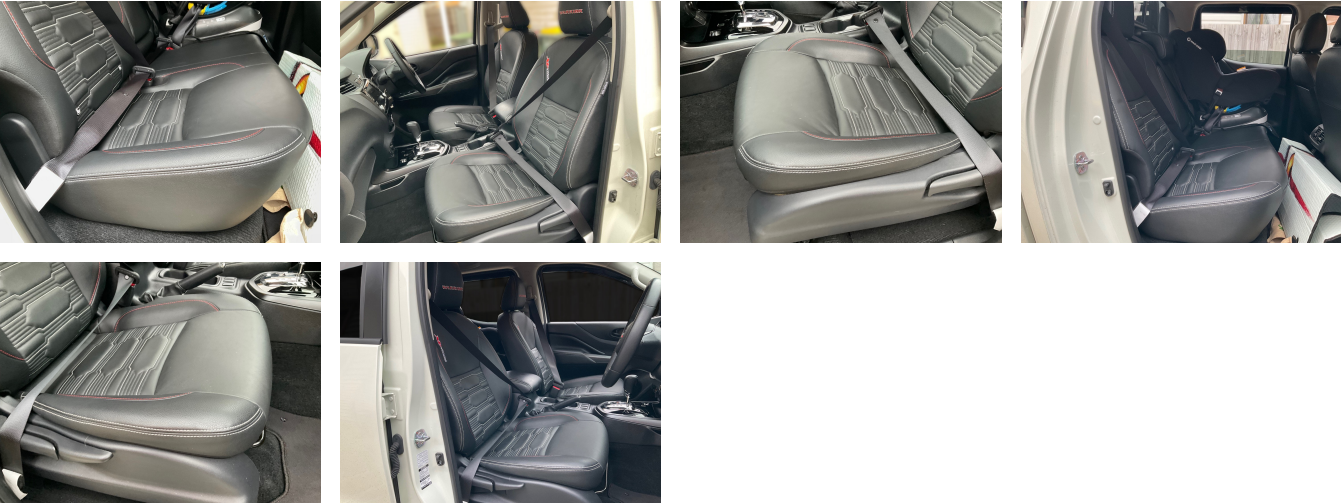
Working well at the time of inspection. Normal wear evident to the seats, belts, buckles and components consistent with the age and mileage.

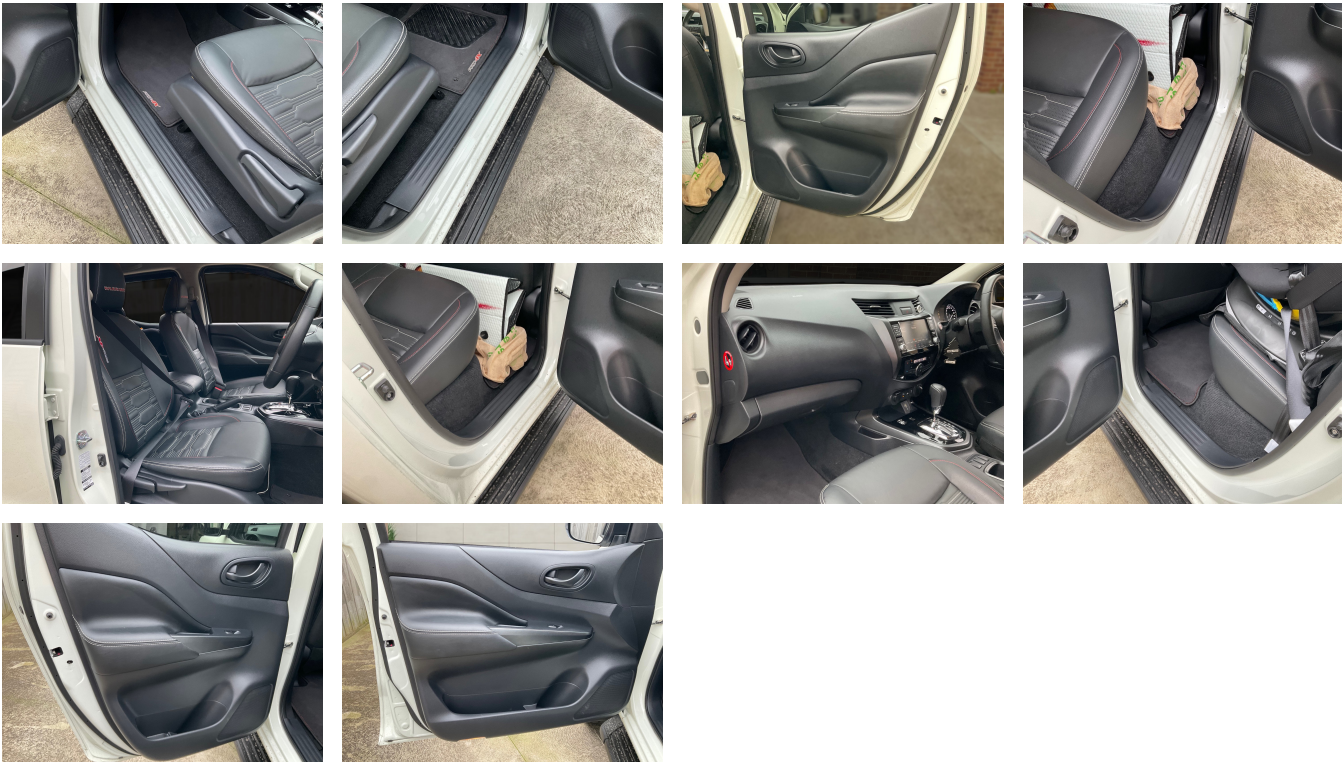
Interior trims, carpet and roof lining in good visual condition, minor wear or marks evident, clean and tidy for the age and mileage.

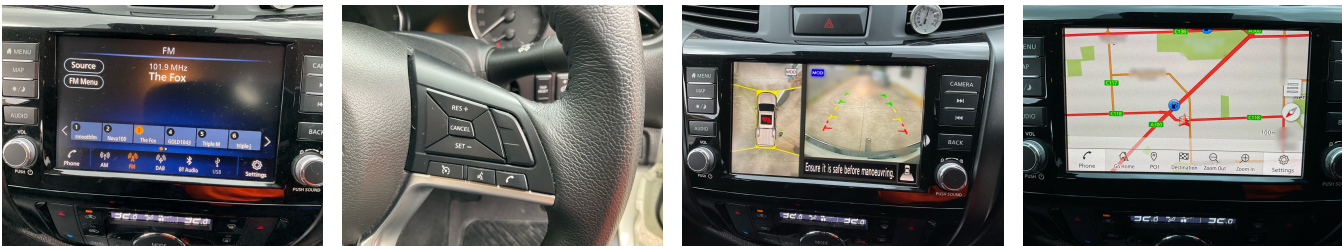
Standard radio fitted, steering wheel audio controls, navigation and reverse camera, all in good working order.

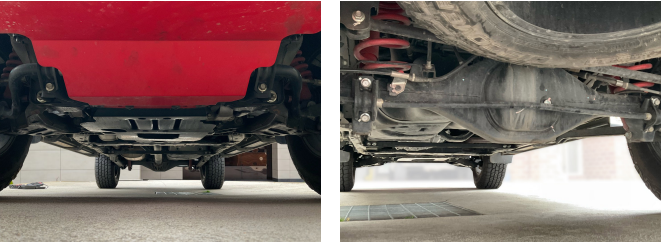
Superficial wear and marks to the frames and members consistent with the age and mileage travelled. Normal wear and minor scuffs (underside of the front bumper bar and under tray) to the underbody components consistent with the age and mileage displayed.

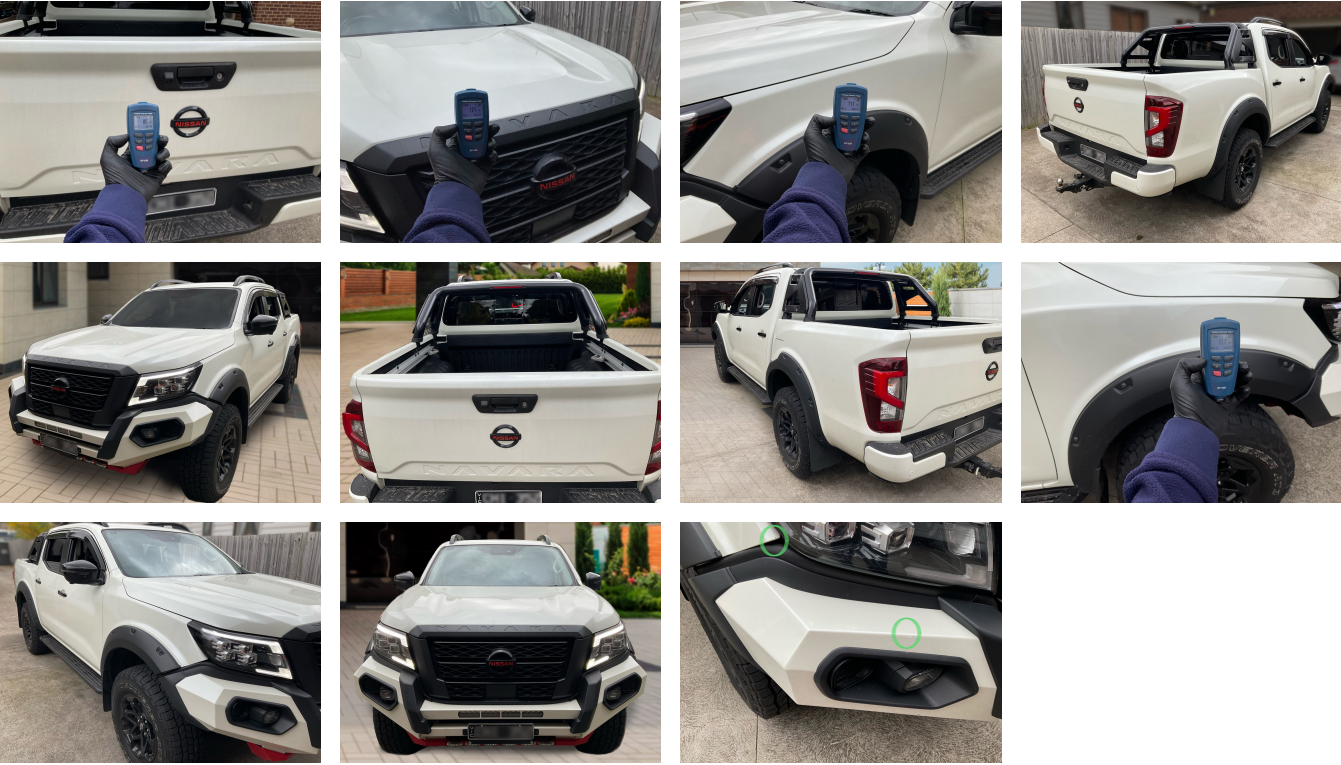
Vehicle presents well at the time, minor sundry marks and light scratches. All attempts are made to detect hail damage but weather and vehicle condition can minimize detection. It is the buyers responsibility to conduct a final inspection prior to purchase, as we can only advise on the condition at the time of inspection.

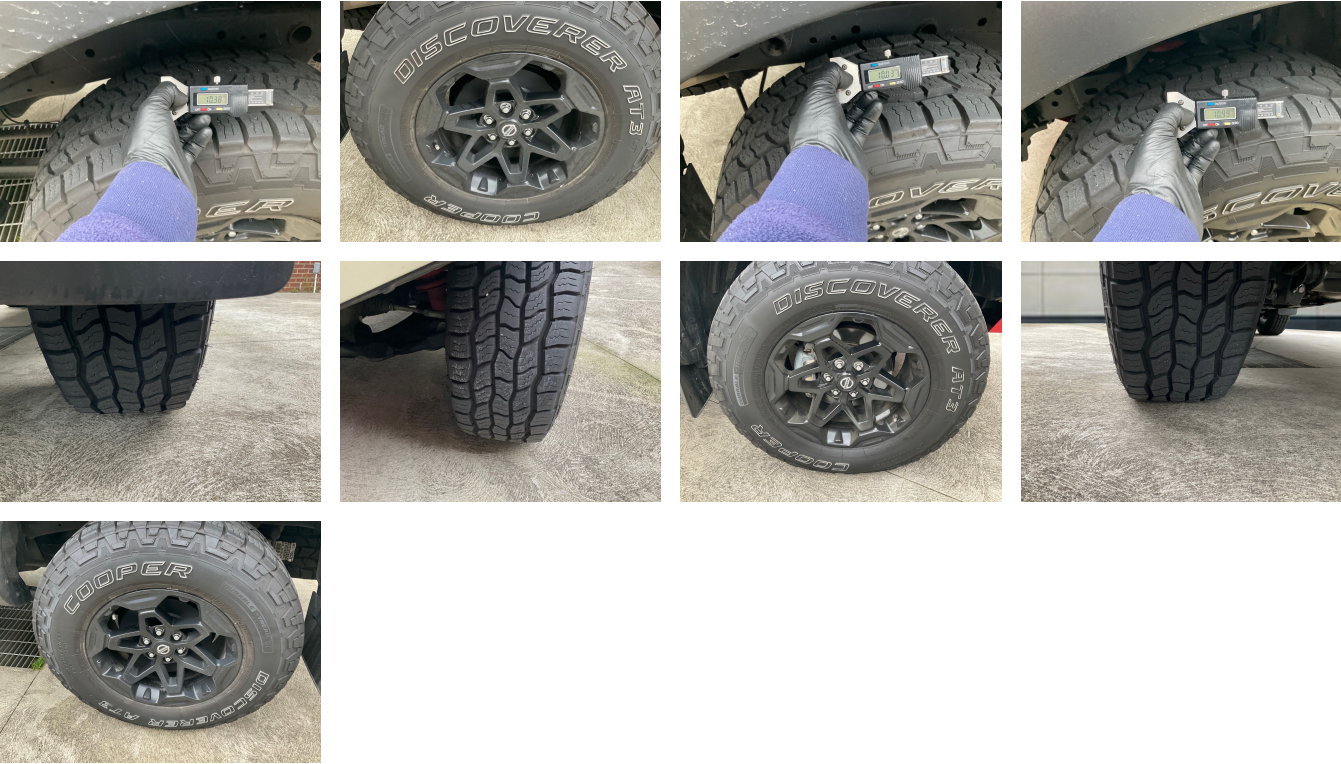
Front and rear tyres have approx. 9.54mm tread remaining to the front and 10.03mm tread remaining to the rear. Tyres fitted to the vehicle complies with manufacturer speed and load rating requirements. Minor wear visible to wheel rims.
