# Pre Purchase Inspection Report

Date completed: 30/04/2024

**Land Rover Range Rover Evoque D200 R-Dynamic SE L551**

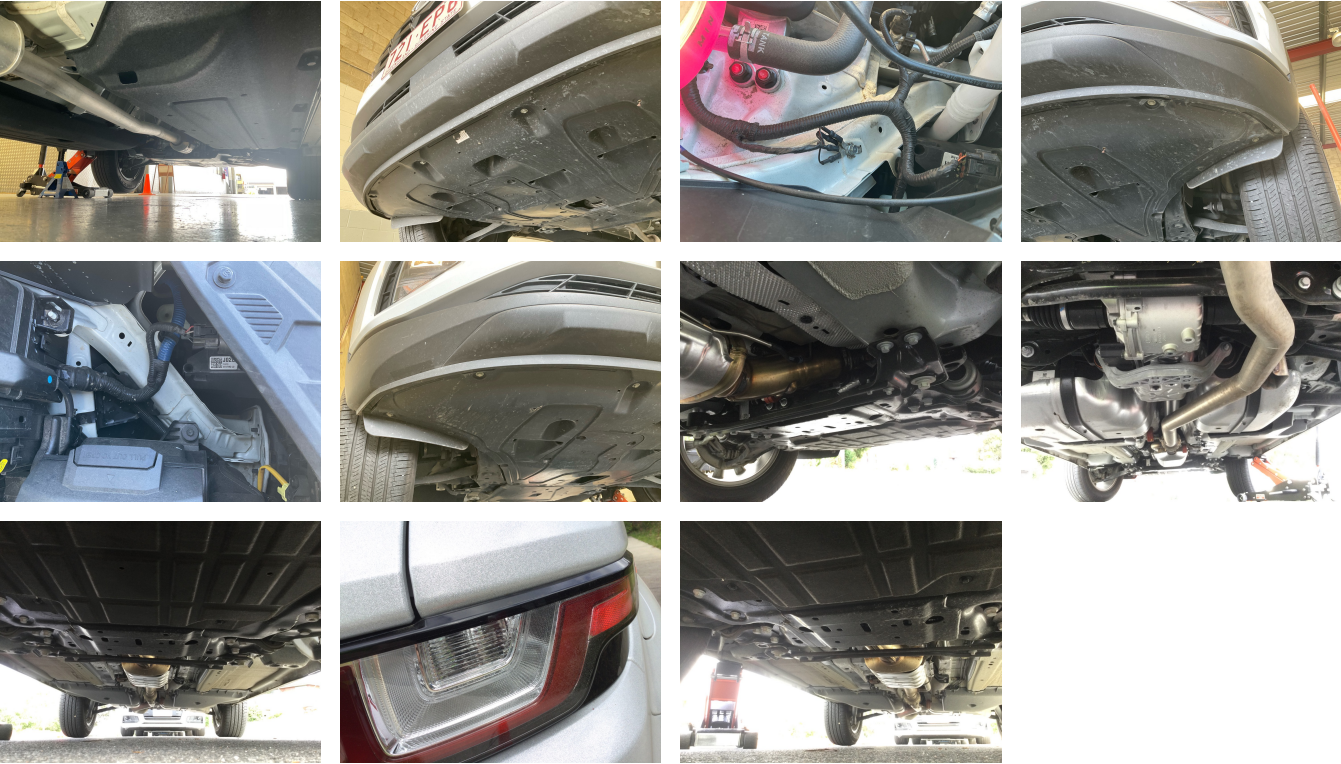
Underbody, Frames and Members

Superficial wear and marks to the frames and members consistent with the age and mileage travelled. Normal wear and minor scuffs (underside of the front bumper bar and under tray) to the underbody components consistent with the age and mileage displayed.

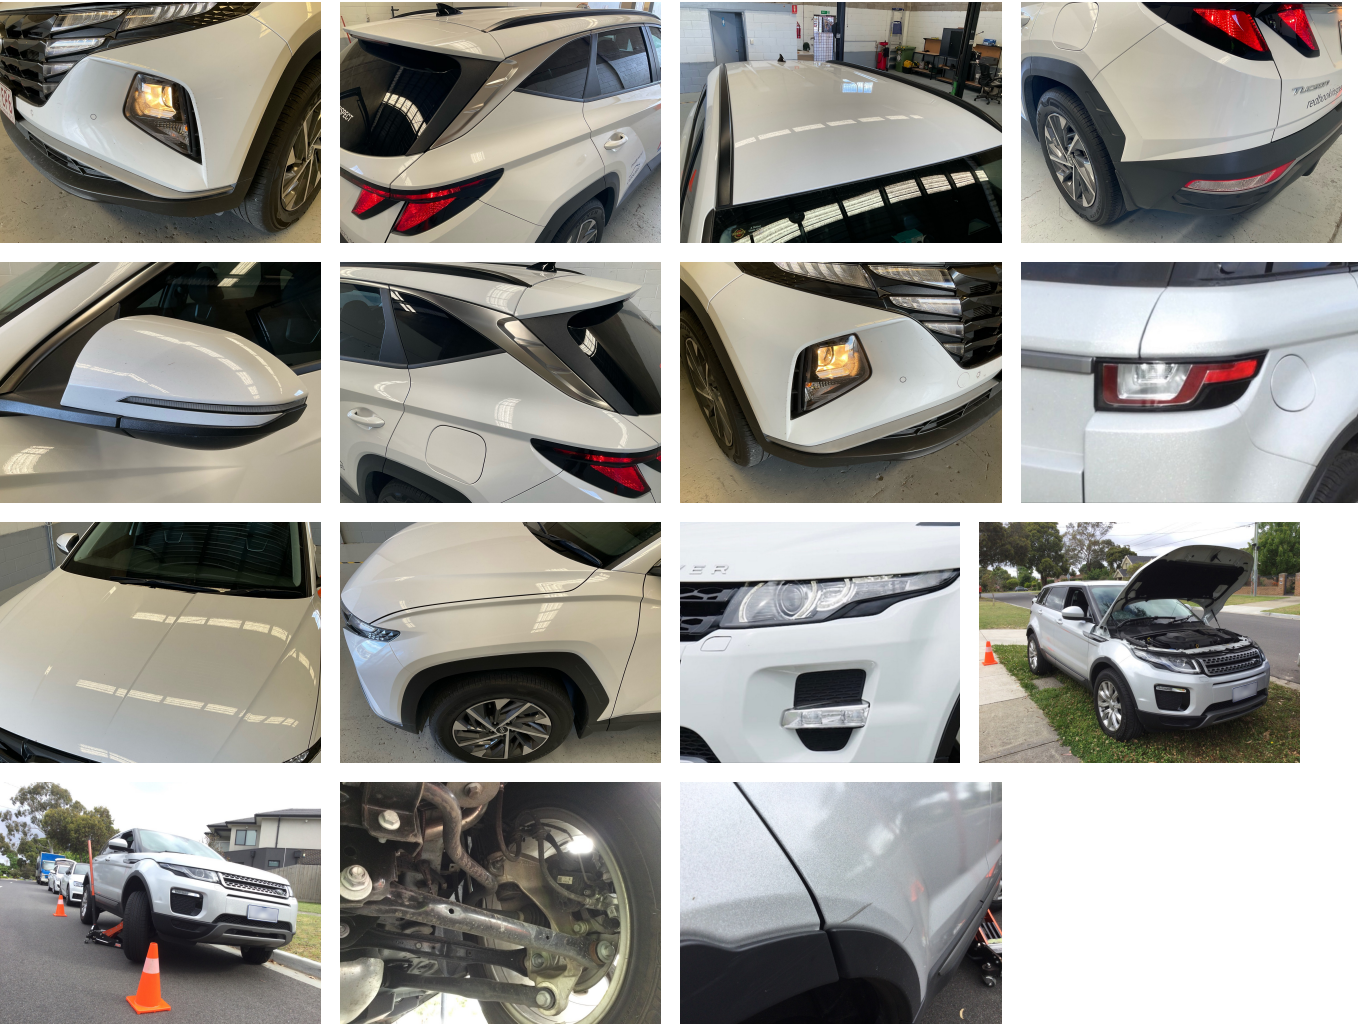
Body Repairs

Vehicle presents well at the time, minor sundry marks and light scratches. All attempts are made to detect hail damage but weather and vehicle condition can minimize detection. It is the buyers responsibility to conduct a final inspection prior to purchase, as we can only advise on the condition at the time of inspection.

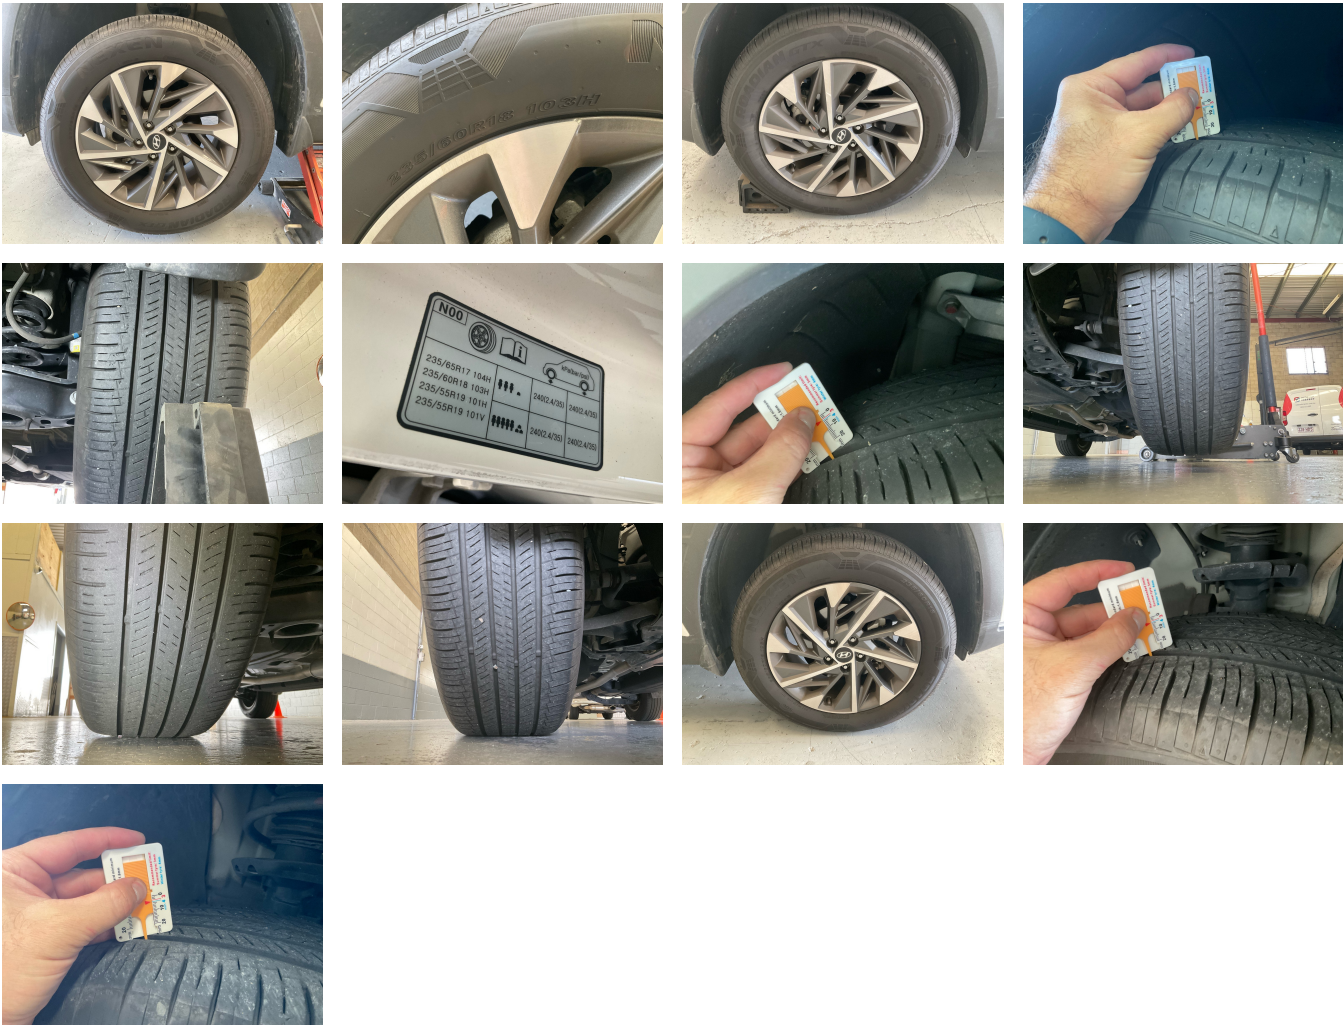
Tyres and Wheel Rims  
★★★★★ 2.0

Very limited wear remaining to the front and rear tyres. Tyres fitted to the vehicle complies with manufacturer speed and load rating requirements. Alignment required, and tyres to be replaced.
