# Ultimate Pre Purchase Inspection

Date completed: 24/04/2024

## Hyundai Tucson

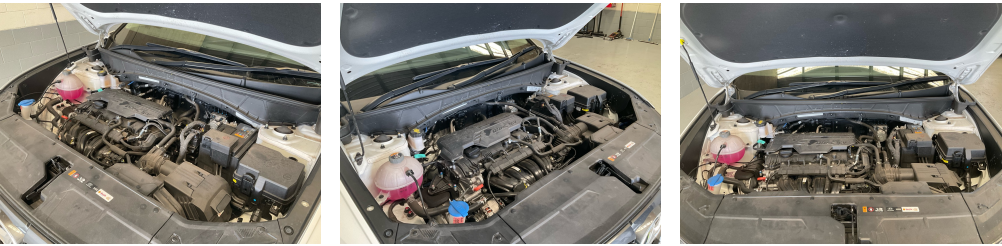
Engine / Motor Noise

Normal operational noise from the engine bay on both cold and warm start at the time of inspection.

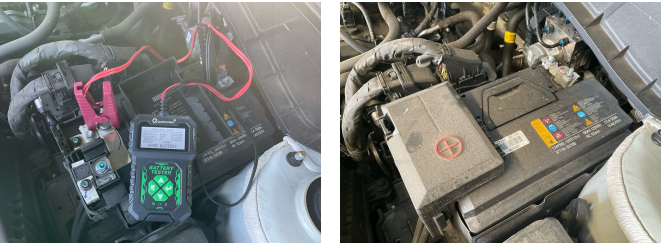
Start-Up Battery Charge Test

Battery test returned "OK" result at the time of inspection. This indicates the battery is working as expected, showing normal wear for age/mileage.

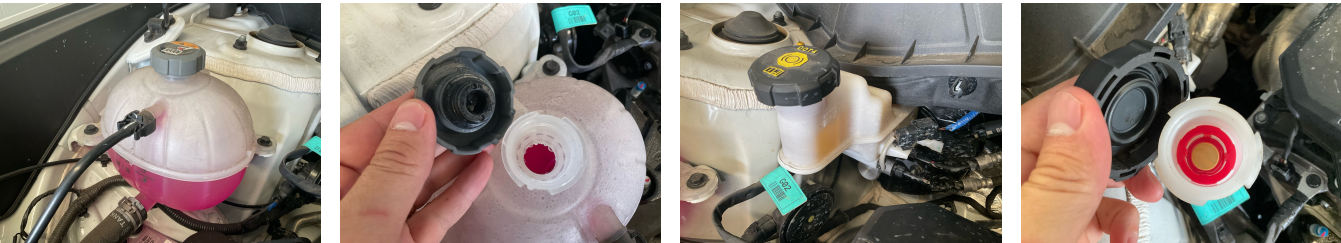
Engine Bay Fluid Levels

All visible engine bay fluid levels within range at the time of inspection.

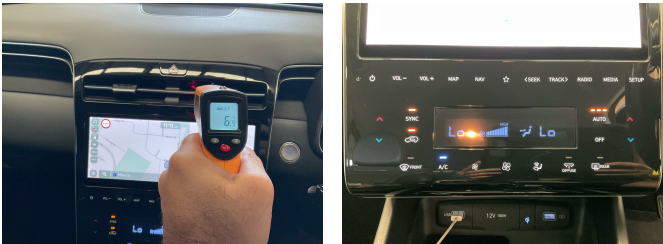
Air Conditioning  
★★★★★ 4.0

Air conditioning cold and working well at the time of inspection. Normal wear evident to the air conditioning components consistent with the age and mileage.

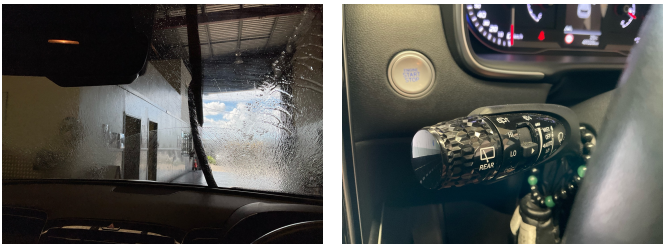
Washers and Wipers  
★★★★★ 4.0

Working well at the time of inspection. Normal wear evident to the windscreen washers, wipers and components consistent with the age and mileage.

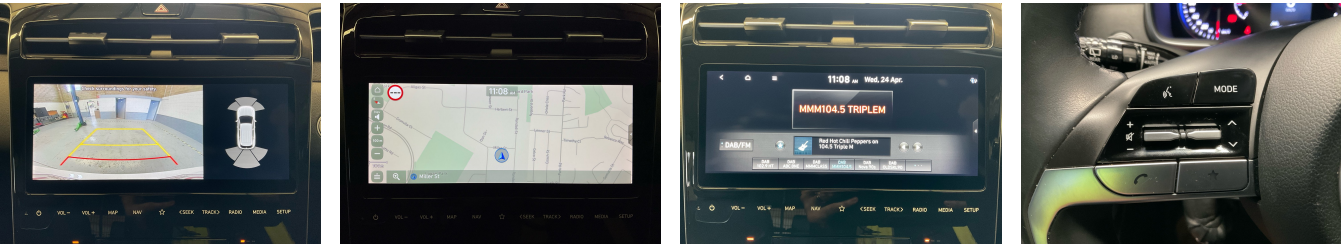
Radio Operation  
★★★★☆ 4.0

Standard radio fitted, superficial wear to the audio controls consistent with the age and KMs travelled.

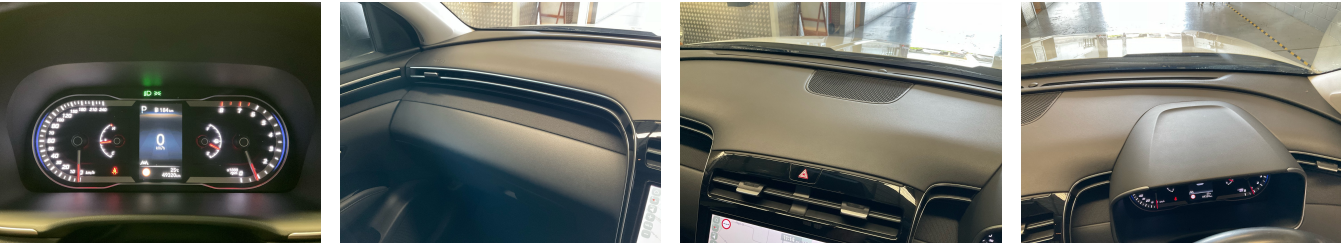
Dash Lights, Gauges and Charging Display  
★★★★☆ 4.0

No abnormal warning lights on in the dash cluster, no faults logged into the vehicle electronics at the time, normal wear evident to the dashboard gauges and trims.

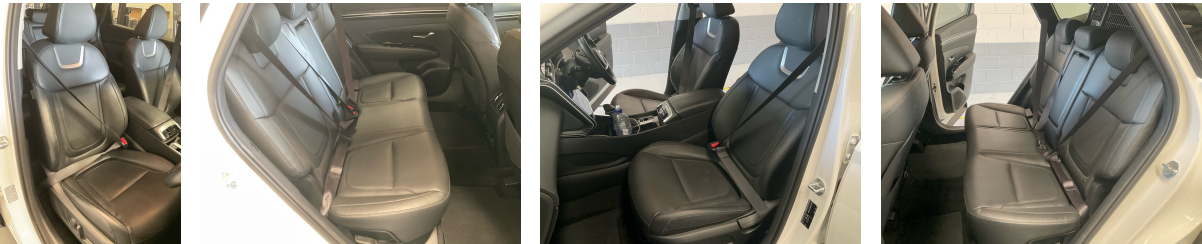
Seats and Seat Belts  
★★★★☆ 4.0

Working well at the time of inspection. Normal wear evident to the seats, belts, buckles and components consistent with the age and mileage.

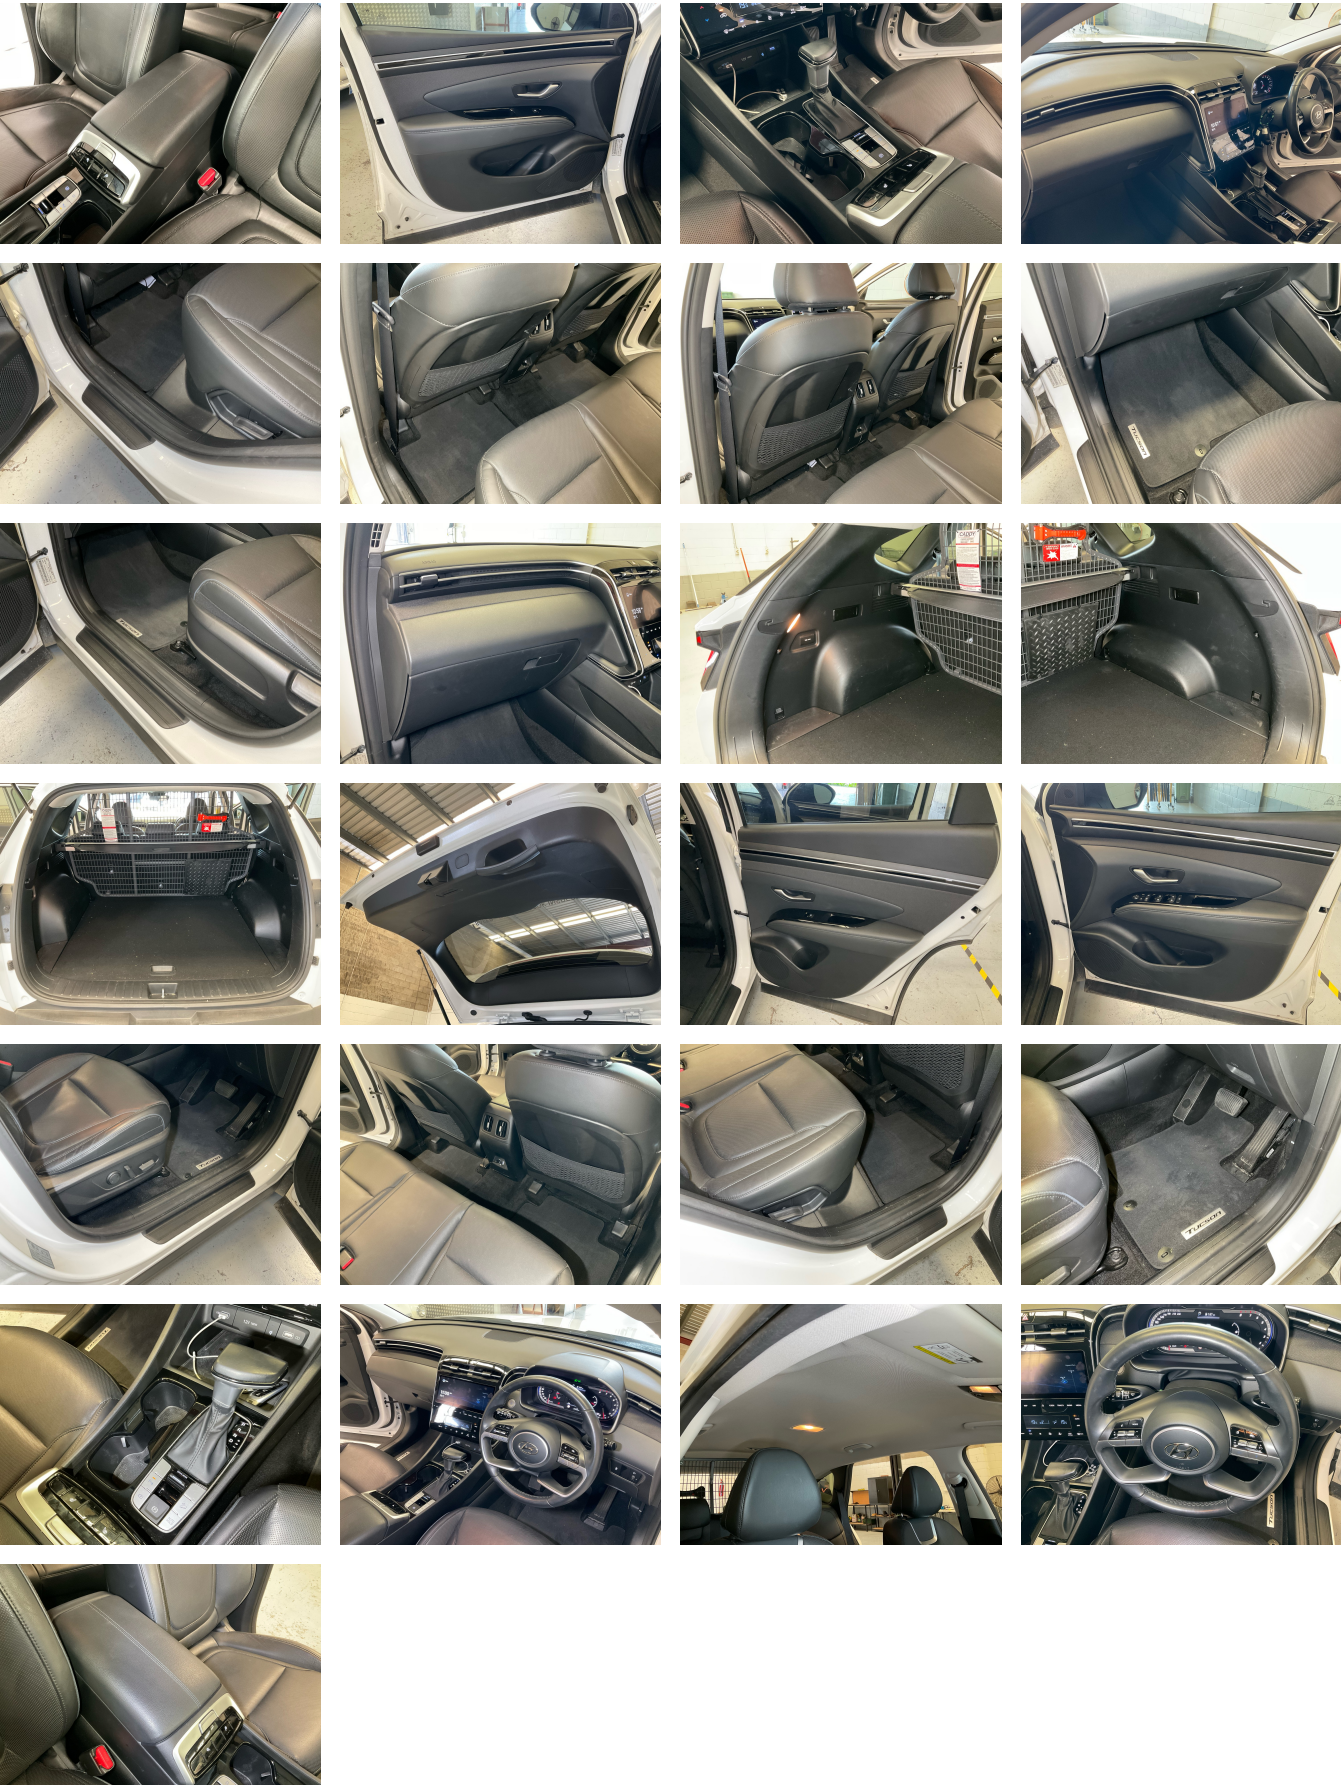
Interior Trims

Interior trims, carpet and roof lining in good visual condition, minor wear or marks evident, clean and tidy for the age and mileage.

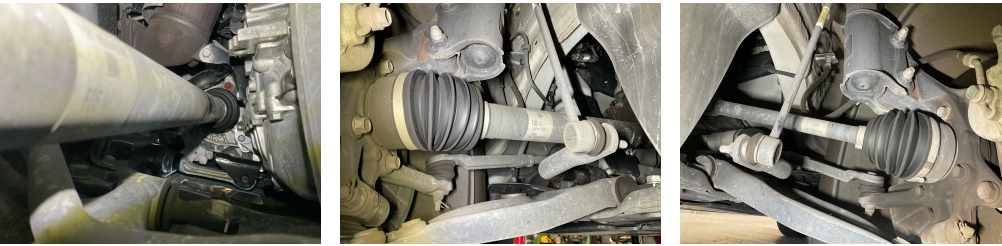
Drive Shafts  
★★★★☆ 4.0

Working well at the time of inspection. Normal wear evident to the visible driveshafts, boots and joint components consistent with the age and mileage.

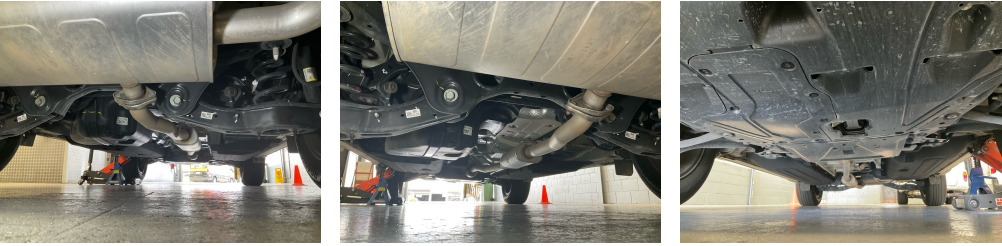
Rust  
★★★★☆ 4.0

No visible rust or corrosion to the vehicle at the time of inspection. The scope of the inspection does not include removal of components, only what is visible at the time. Paint and underbody sealer may inhibit detection of rust and corrosion.

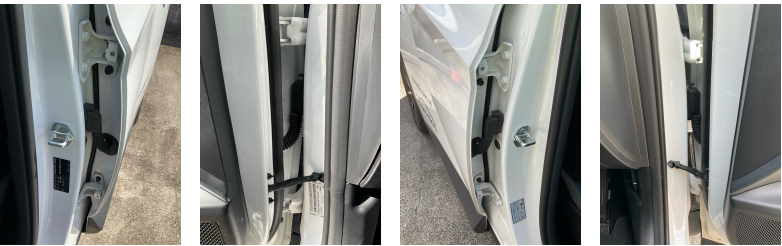
Doors, Locks and Hinges  
★★★★☆ 4.0

Normal wear and marks to the door, locks, hinges and seals consistent with the age and mileage.

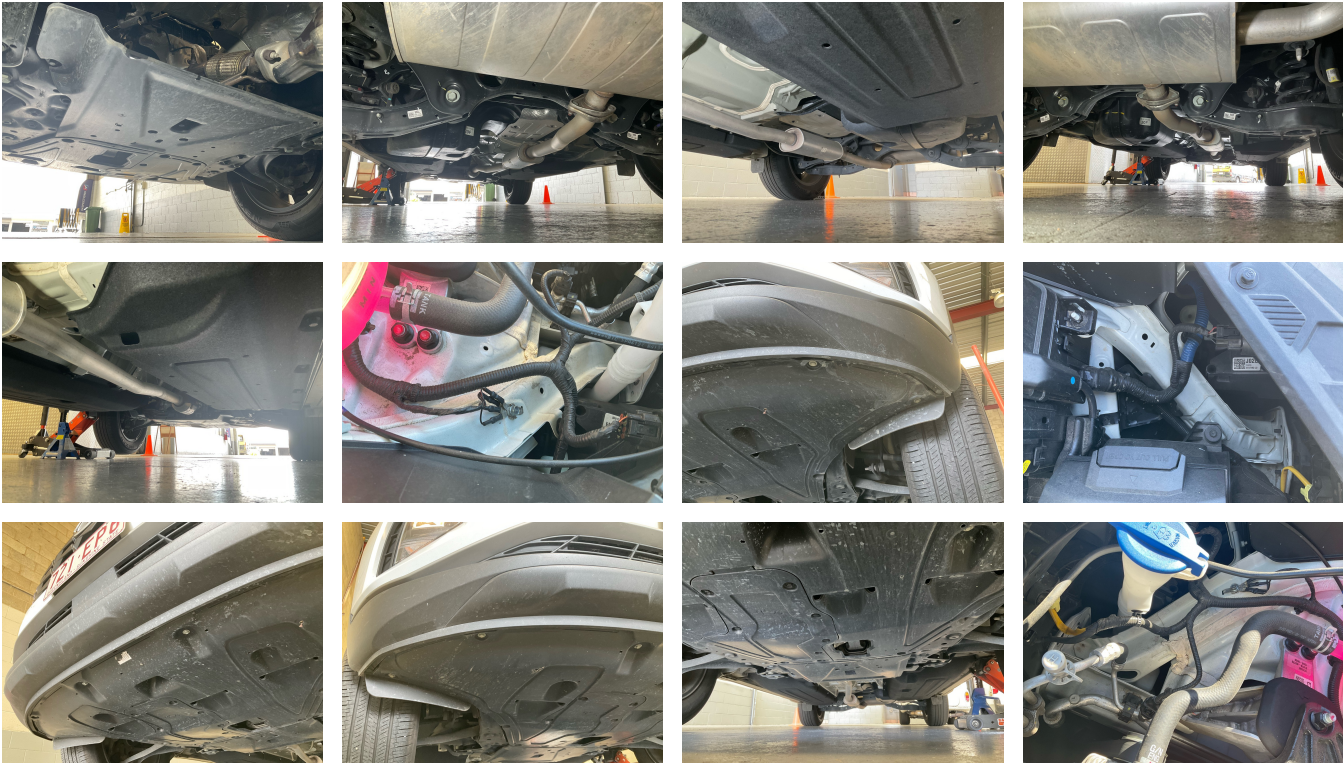
Underbody, Frames and Members

Superficial wear and marks to the frames and members consistent with the age and mileage travelled. Normal wear and minor scuffs (underside of the front bumper bar and under tray) to the underbody components consistent with the age and mileage displayed.

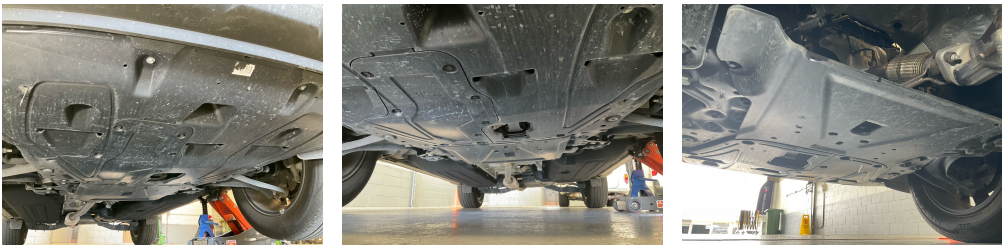
Transmission Performance

Normal wear evident to the visible components consistent with the age and mileage. RedBook Inspect are unable to ascertain the amount of wear to the internal components of the transmission or gearbox.

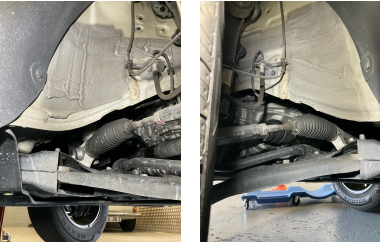
### Steering Components

Working well at the time of inspection. Normal wear evident to the steering gear, linkages and components consistent with the age and mileage.

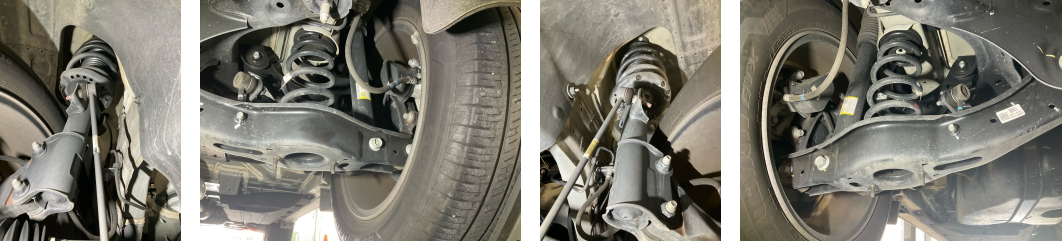
Front and Rear Suspension Components

Normal wear evident to the front and rear suspension components including visible rubber bushes consistent with the age and mileage.

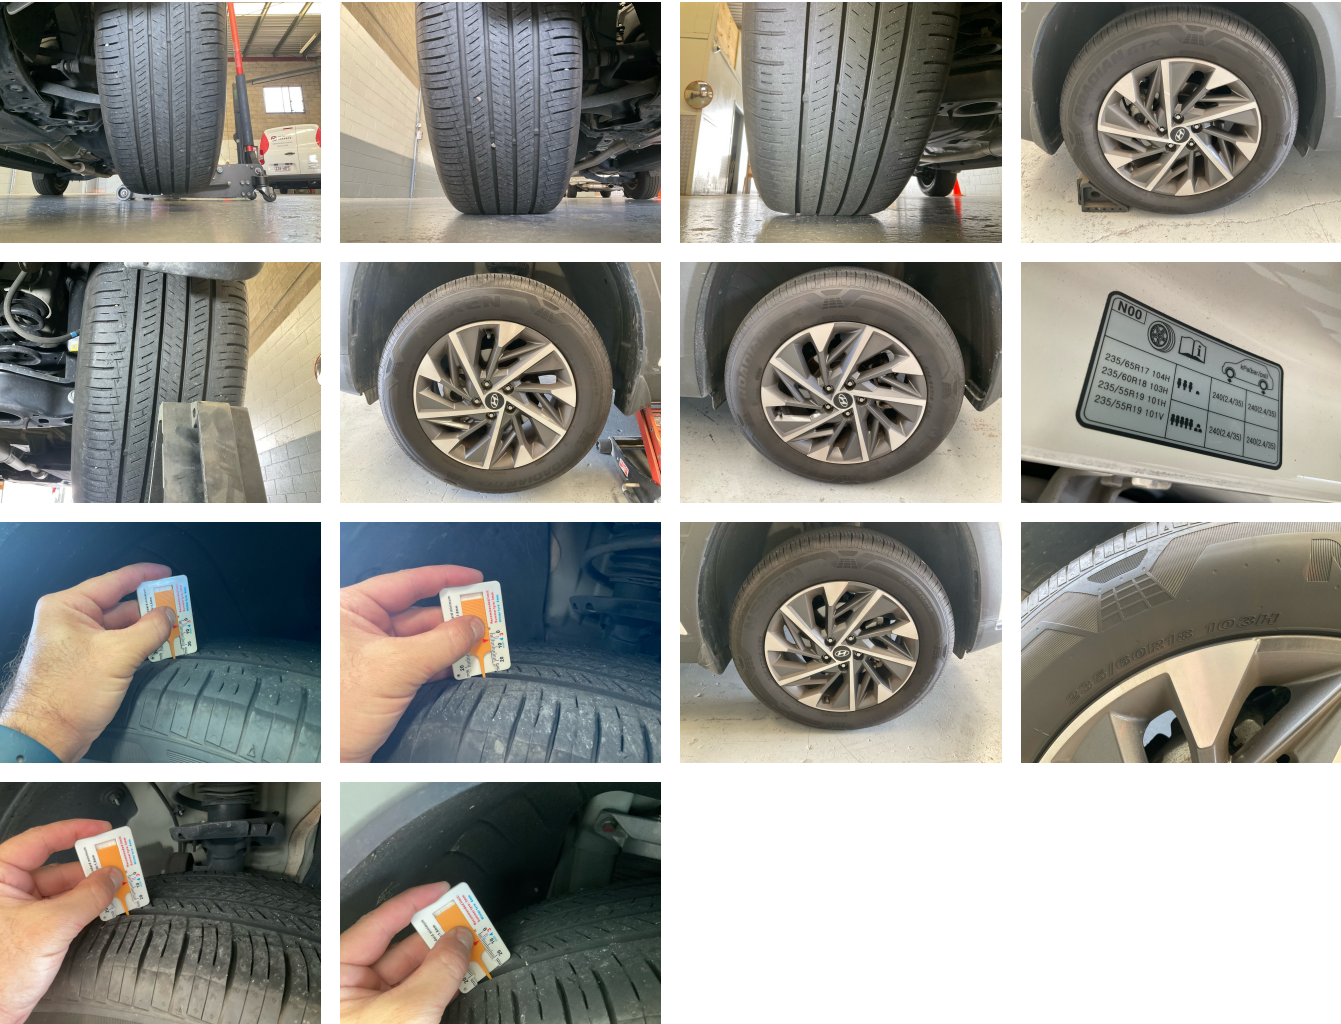
Tyres and Wheel Rims

General wear to the front and rear wheel tyres with approx. 3-4mm tread remaining to the front and approx. 3-4mm tread remaining to the rear. Tyres fitted to the vehicle complies with manufacturer speed and load rating requirements. Minor wear visible to wheel rims.?
