# Lite Pre Purchase Inspection

Date completed: 12/04/2024

**Hyundai Tucson**

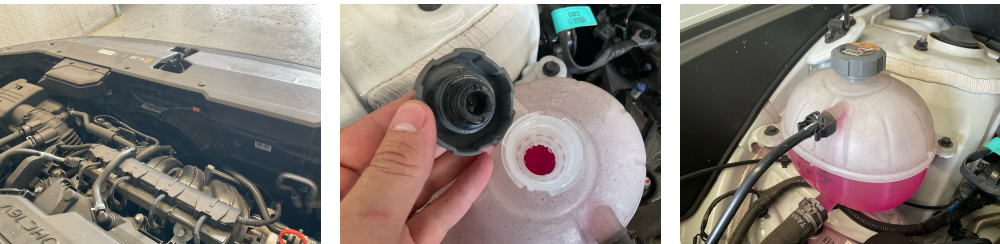
Fan, Radiator and Cap  
★★★★★ 4.0

Normal wear to the cooling system components consistent with the age and mileage displayed. No visible leaks detected at the time of inspection.

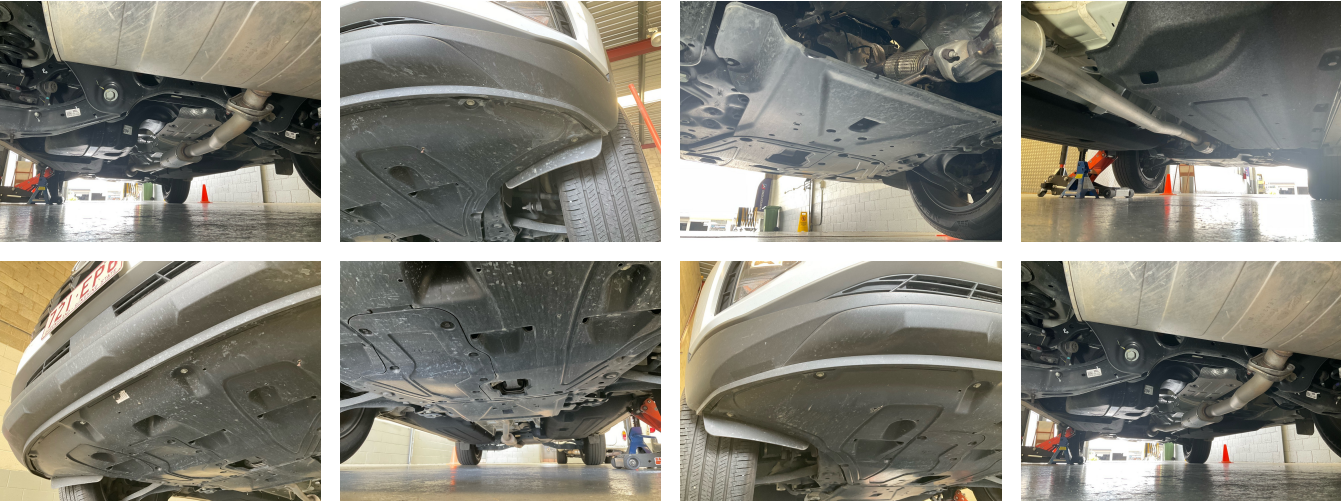
Underbody, Frames and Members

Superficial wear and marks to the frames and members consistent with the age and mileage travelled. Normal wear and minor scuffs (underside of the front bumper bar and under tray) to the underbody components consistent with the age and mileage displayed.

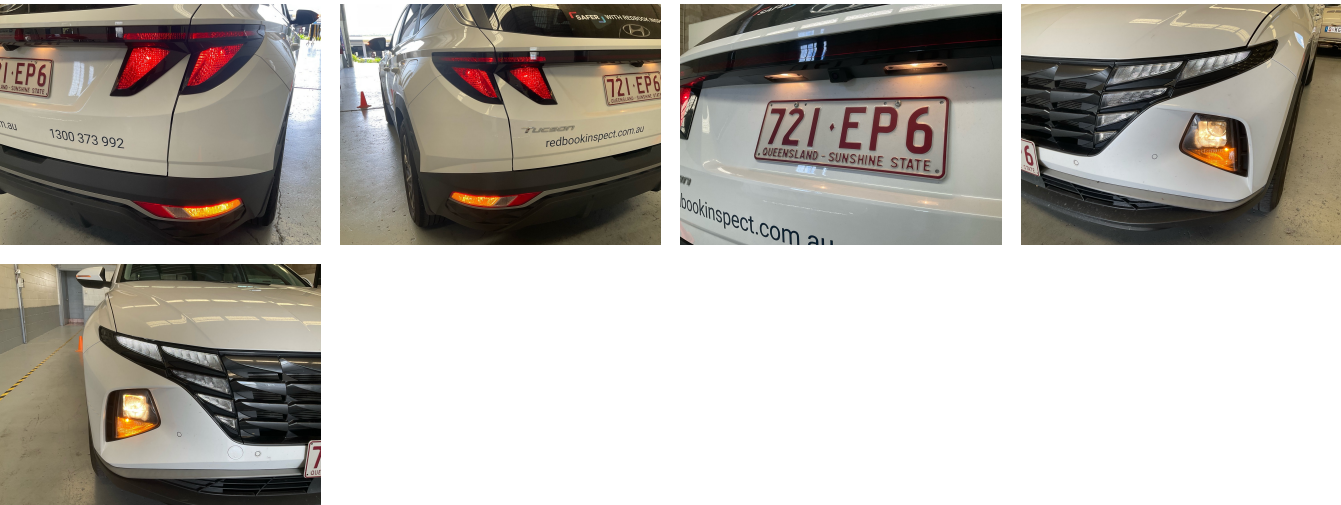
Exterior Lights

All Exterior lights working well at the time of testing, general wear and oxidation to the exterior light lens consistent with the age and mileage.

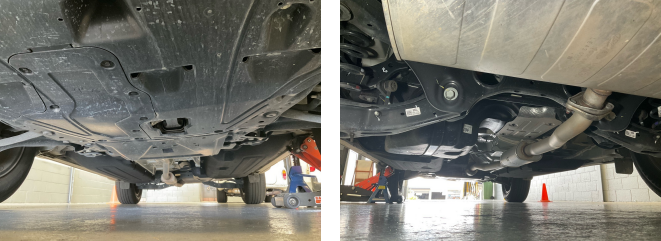
**Rust**

No visible rust or corrosion to the vehicle at the time of inspection. The scope of the inspection does not include removal of components, only what is visible at the time. Paint and underbody sealer may inhibit detection of rust and corrosion.

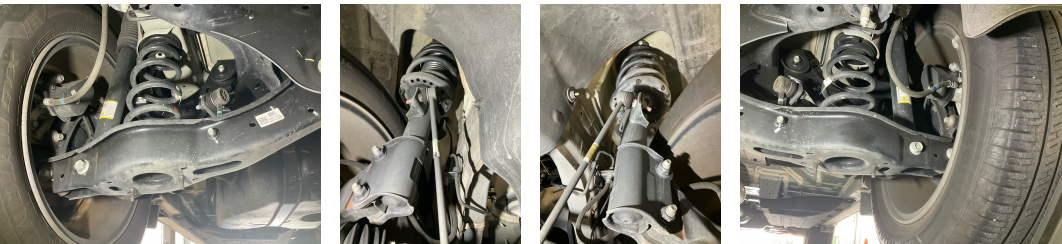
**Front and Rear Suspension Components**

Normal wear evident to the front and rear suspension components including visible rubber bushes consistent with the age and mileage.

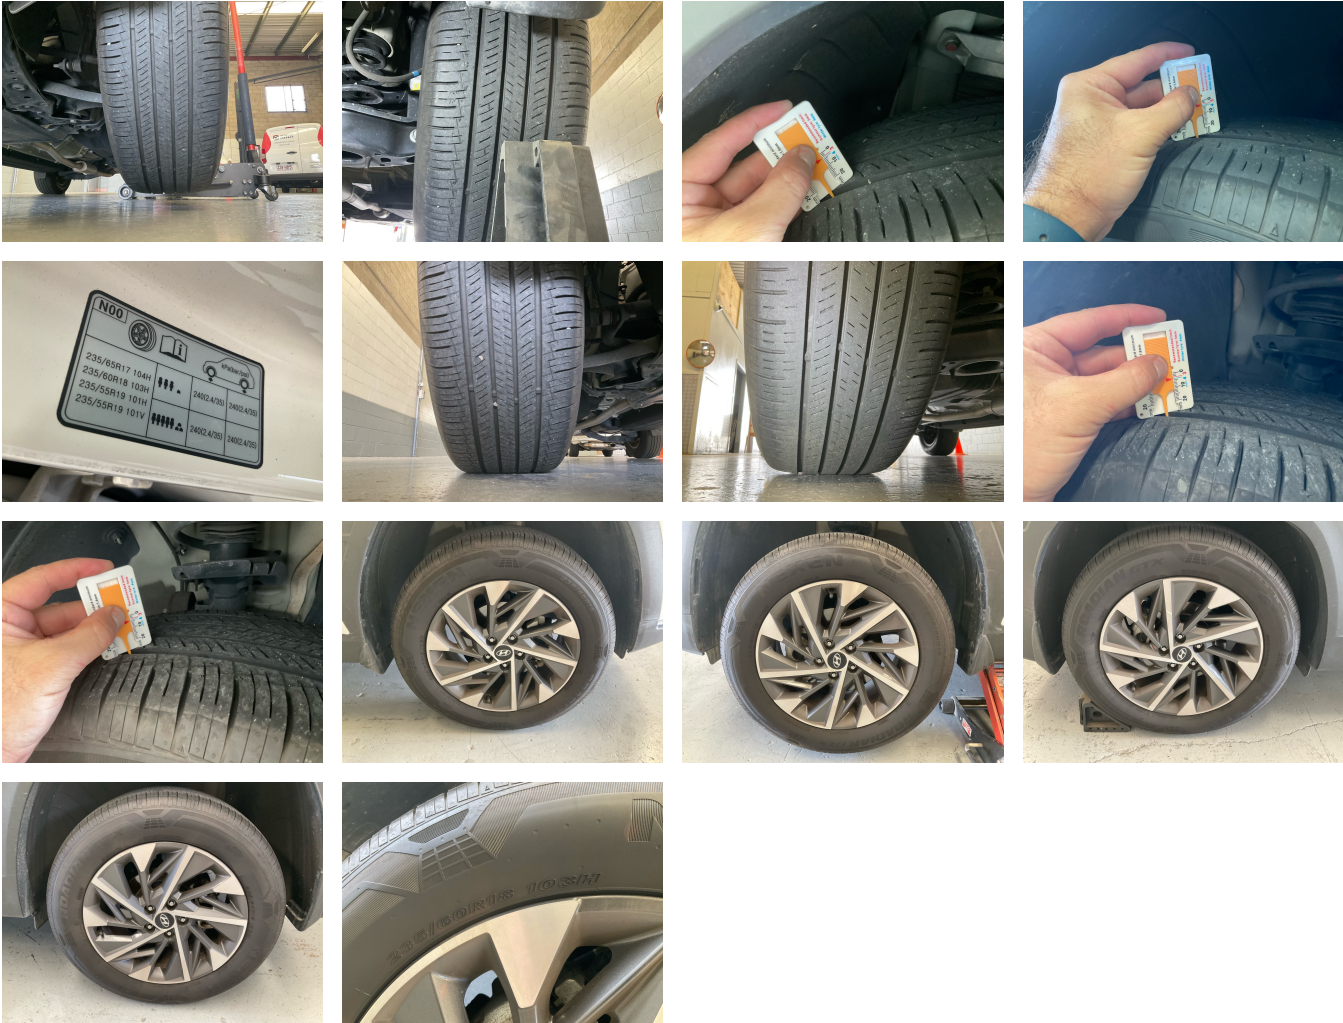
Tyres and Wheel Rims  
★★★★★ 3.0

General wear to the front and rear tyres with approx. 3-4mm tread remaining to the front and approx. 3-4mm tread remaining to the rear. Tyres fitted to the vehicle complies with manufacturer speed and load rating requirements.

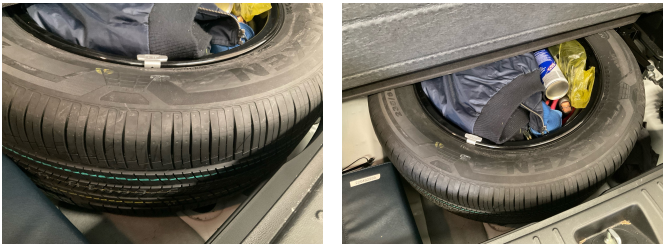
Spare Tyre and Rim  
★★★★★ 4.0

Spare tyre present and shows minor wear at time of inspection.
